TECHNICAL ASSISTANCE TEAM FOR EMERGENCY RESPONSE REMOVAL AND PREVENTION  
EPA CONTRACT 68-01-7367

Re: Interstate Pollution Control, Rockford, Illinois  
TDD# 5-8807-12

**SITE ASSESSMENT  
FOR  
INTERSTATE POLLUTION CONTROL  
ROCKFORD, ILLINOIS**

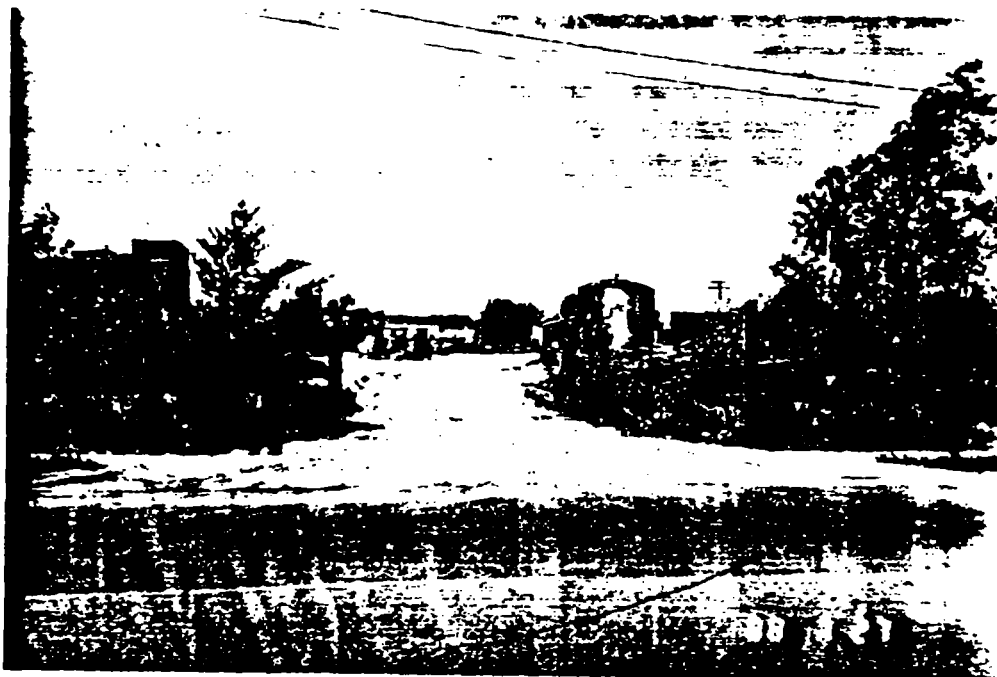
PHOTOGRAPH #1

Interstate Pollution Control, Rockford, Illinois  
Front gate and entrance road to the site; looking west  
across Seminary Road.

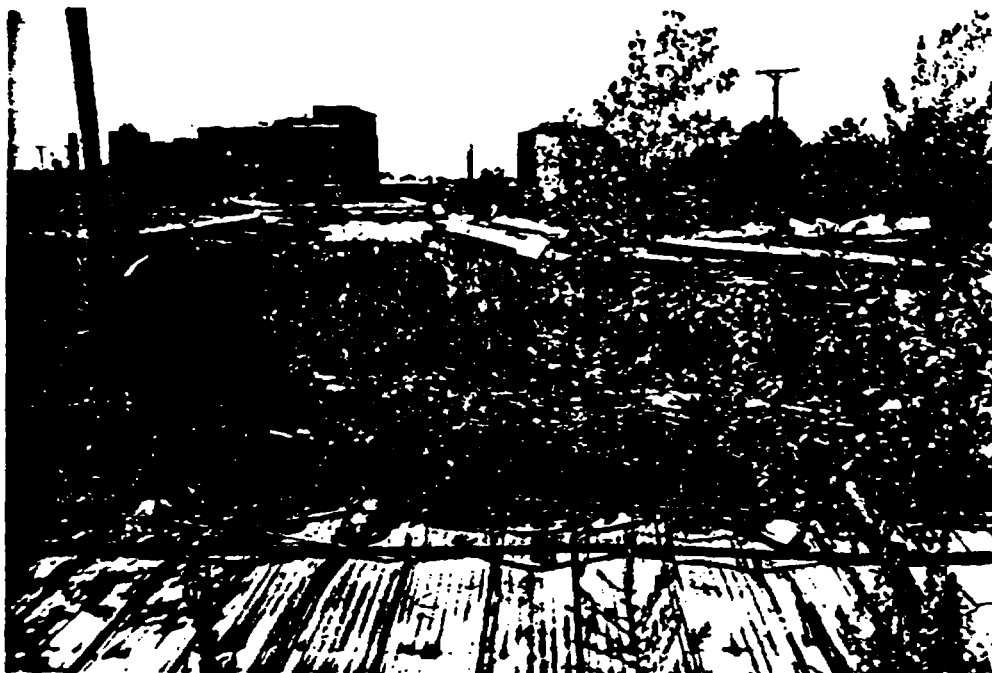
PHOTOGRAPH #2

Interstate Pollution Control, Rockford, Illinois  
Backfilled and capped sludge disposal lagoon now covered  
with scrap wood and metal. Looking west past the fallen  
sheet metal fence from along the east border of the site.

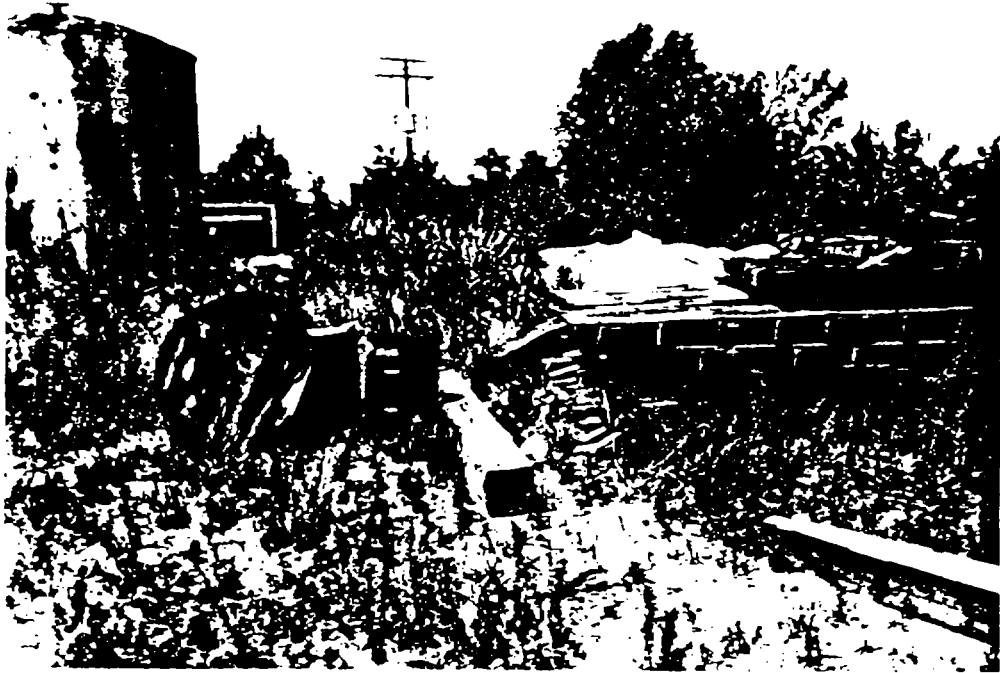
PHOTOGRAPH #3

The sludge lagoon on-site had been filled and capped with clay and was covered with scrap metal and debris. Mr. Skoglund reported that the lagoon sludges and liquids had been removed prior to the capping. He did not recall exactly when this took place.

Interstate Pollution Control, Rockford, Illinois  
 Capped Lagoon covered with scrap metal, wood and empty  
 drums. Looking west.

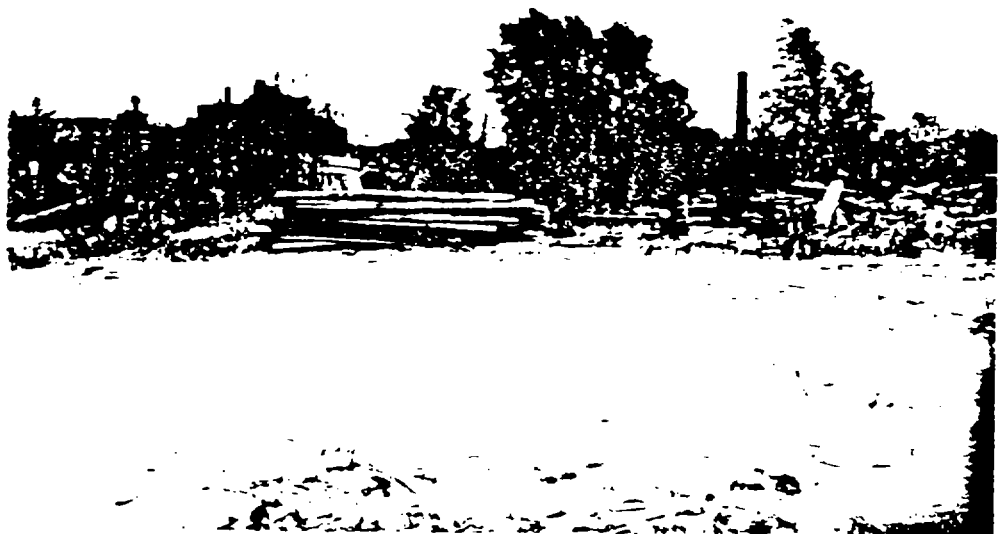
PHOTOGRAPH #4

Capped Lagoon covered with scrap metal, wood and empty

drums. Looking west.

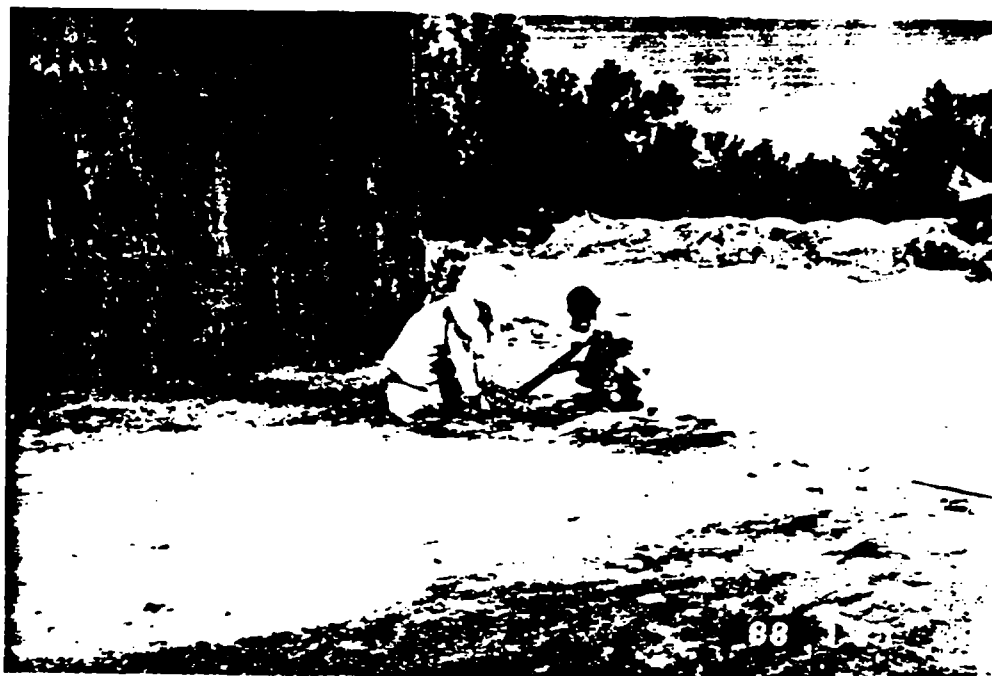
PHOTOGRAPH #7

The TAT, under the direction of OSC Zintak, collected two surface soil samples from on-site and one background sample from off-site. Sample 1 consisted of a composite of stained surface soil from two locations near the 100,000 gallon tank. Sample 2 consisted of a composite of surface soil from six locations along the southern perimeter of the site (Figure 3). A background grab sample (3) consisted of surface soil collected from Blackhawk Park, located approximately one-half mile northwest of the site.

The only organic compounds detected above background levels and above detection limits were bis(2-ethylhexyl)phthalate (130 ppm) and di-n-butyl phthalate (49.5 ppm), both at location 2, along the south border of the site.

Interstate Pollution Control, Rockford, Illinois  
Sampling location #1; a stained soil area near the  
storage tank. Looking northeast.

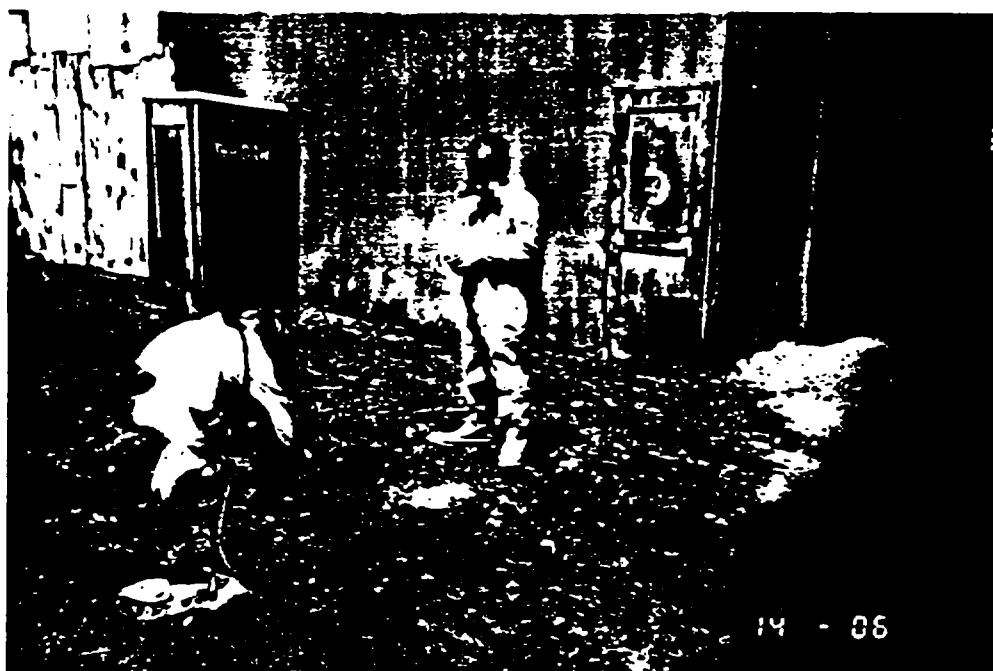
PHOTOGRAPH #8

Interstate Pollution Control, Rockford, Illinois  
One of six surface soil locations composited to form  
sample #2. Looking northwest from the southern border  
of the site. This sample was taken near the garage on  
the site.
